Unique FT Waterproofing Technology For Asbestos, Tin, Gi, Iron & Roofing Sheets

COMPANY PROFILE

Mangalore Tile Re-reinforcement FT Technology for Repairing & Water Proofing.

WATERPROOFING FT SYSTEM AT A GLANCE

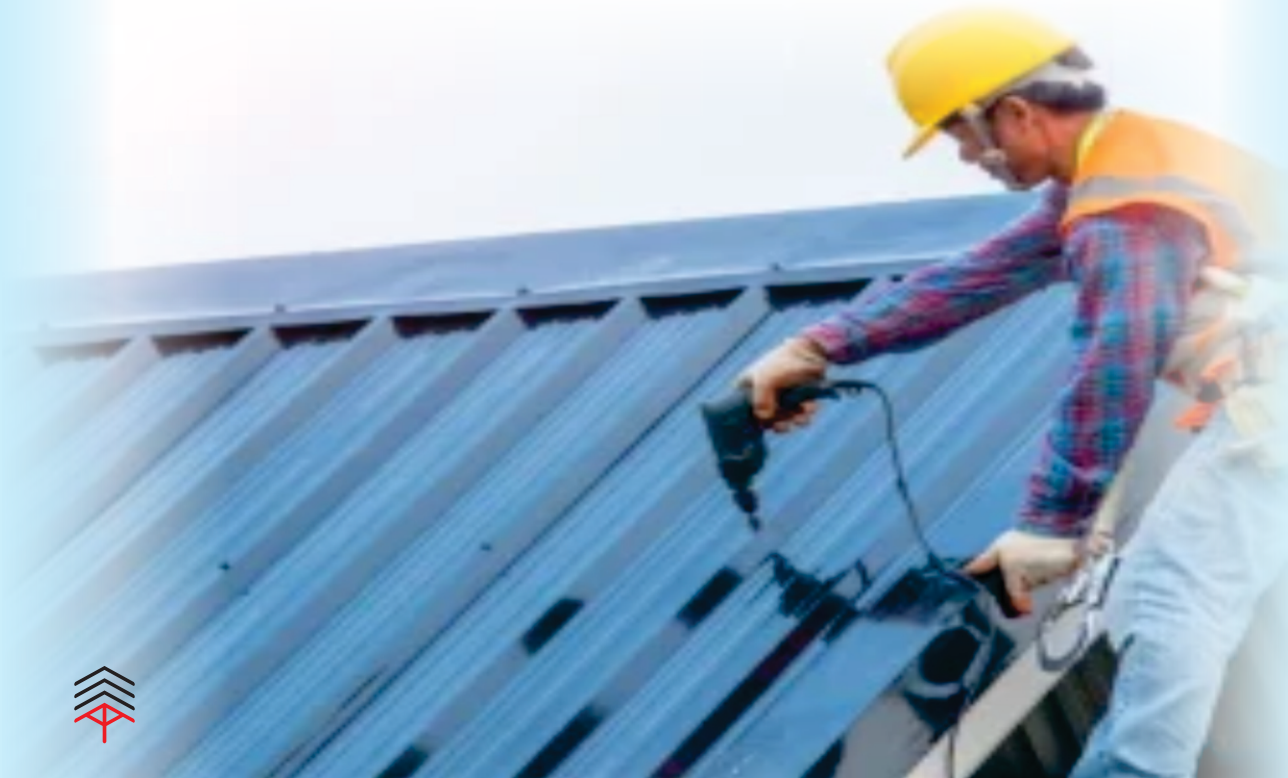
- Clean the surface by rubbing with wire brush to remove dust, fungus, grass root, rust & loose material.
- Wash the surface with SAC[®] surface active chemical
- Wash with mild acid solution
- Wash with clean water
- Repair damaged tile and apply ASP-99 (Primer) to get an even surface & strength.
- Cut a piece of fabric as per the required size for reinforcement.
- Put the fabric on the tile and stick it with glue.
- After 40-50 minutes apply a coat of AWC-99 on the surface by brush and let it dry for one hour give one more coat of WAC-99R on the surface.
- Let it dry for 24 hours for full strength.

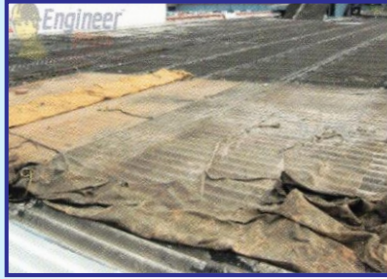
ASBESTOS / ROOFING SHEETS WATERPROOFING

Before

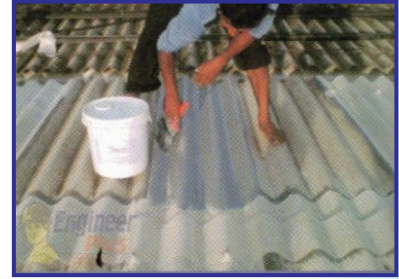
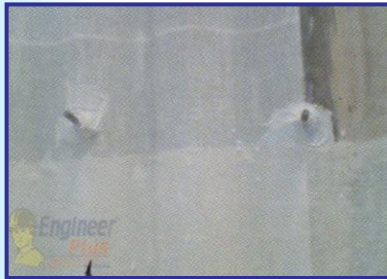
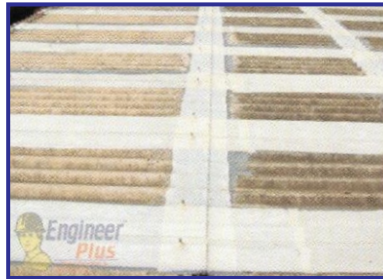
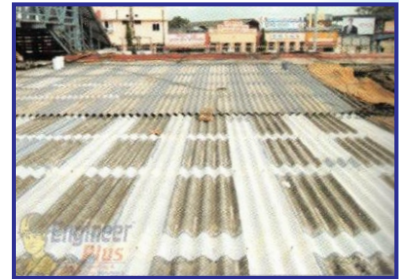
During
